Harbor & Pine Mechanical  
Portland, OR  
(555) 010-0142

Northside Market  
Attn: Jane Roe  
1820 N Williams Ave, Portland, OR 97227

| UNIT | DETAILS |
|---|---|
| Walk-in cooler | details: Heatcraft condensing unit · S/N T19-44812 |

| TYPE OF SERVICE | REFRIGERANT | |
|---|---|---|
| Leak repair | R-404A | |

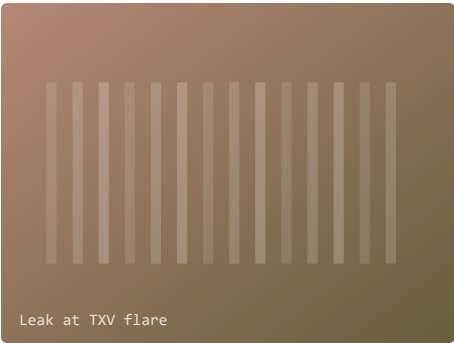
| TYPE OF SERVICE | REFRIGERANT | |
|---|---|---|
| 120 | 48.9 % | |

| Flare nut at the TXV inlet. |

Leak at TXV flare

| Re-made flare, replaced nut, pressure tested at 150 psig for 30 min. |

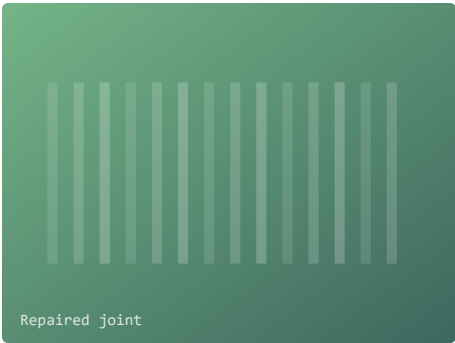
Repaired joint
