Clearflow Hood Cleaning

Bayshore Grill

3201 Bayshore Blvd, Tampa, FL 33629

Oct 7, 2026

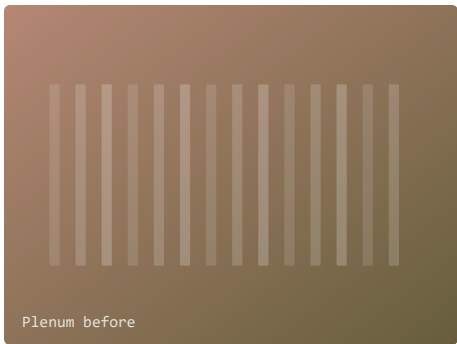
Plenum before

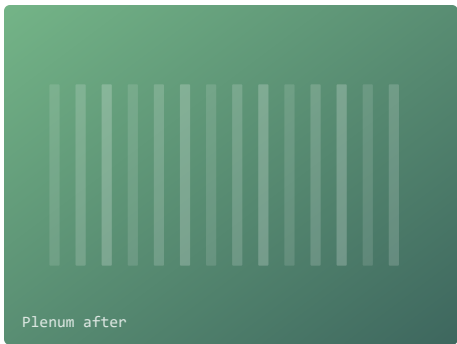
Plenum after

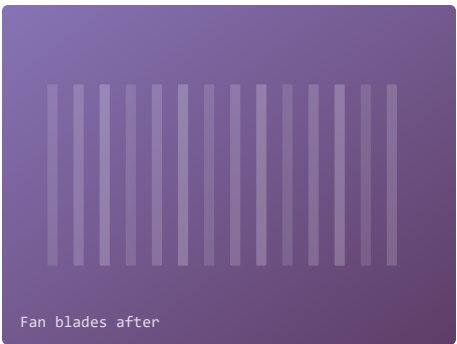
Fan blades after
